Boost Valve Kits

Sonnax Part Summary

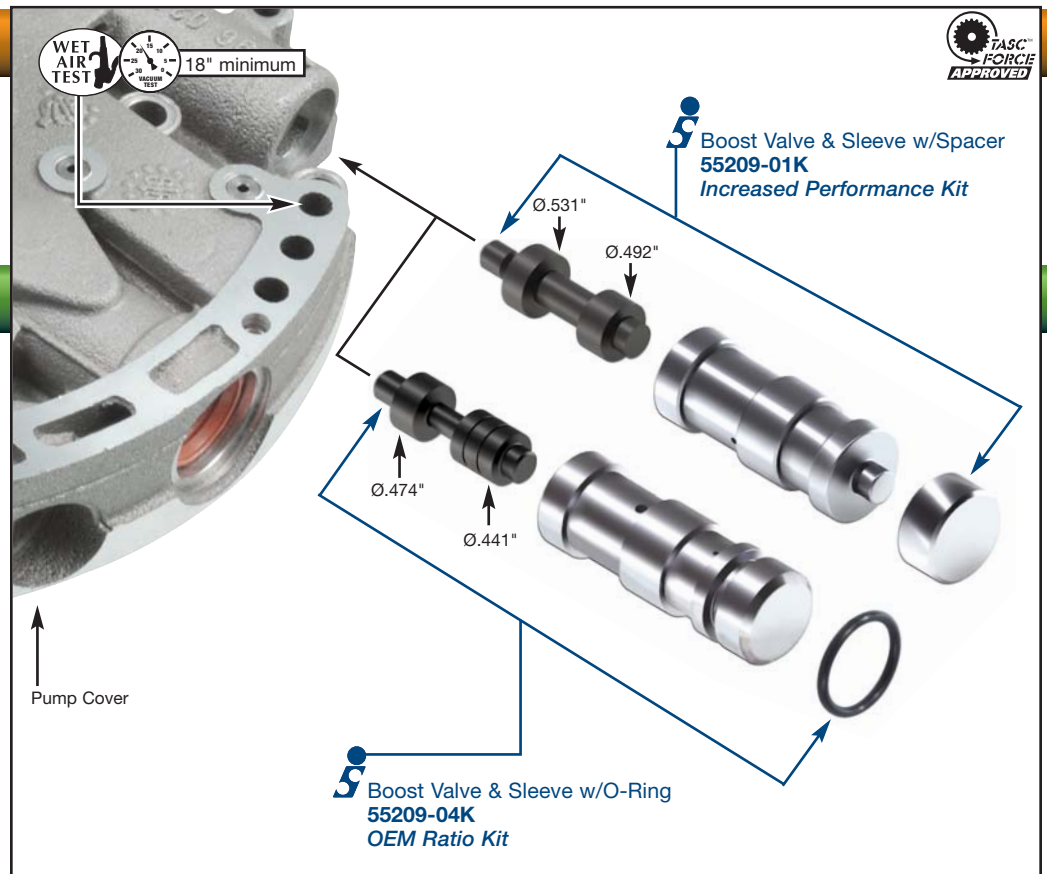
Insufficient line rise or high reverse pressure

- Flare upshifts • TCC slippage or gear ratio codes

The boost sleeve increases line pressure for shift quality, engagement and proper TCC apply. As the sleeve wears, torque signal oil will leak to exhaust and line pressure will not increase as commanded.

These Sonnax kits restore proper clearance with upgrade design and material to prevent EPC and reverse boost loss. Increased performance and OEM ratio kits are available.
