Universal Stator Support Shaft Kits

4L60-E: '04-up Reluctor Style

4L60-E, 4L65-E & 4L70-E:
'04-up Reluctor Style

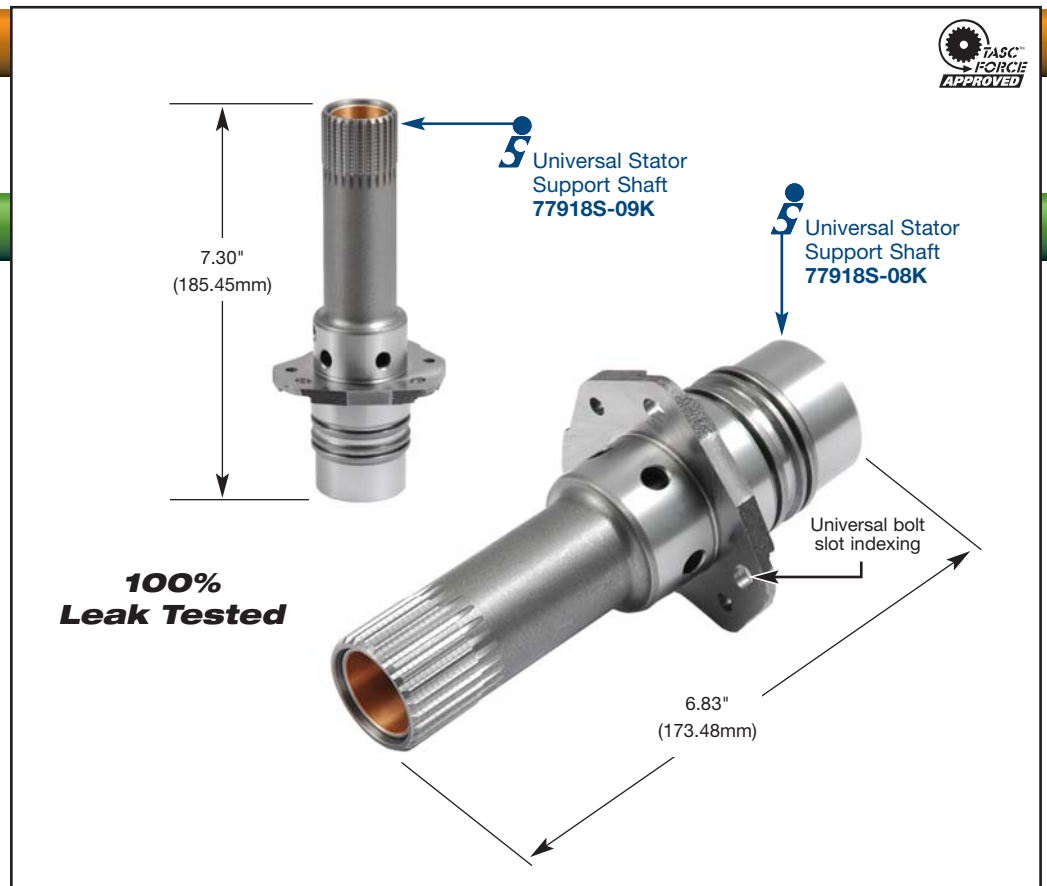
Delayed reverse, code 1870

- No 3rd gear
- 3-4 clutch failure
- Converter overheat

Overheating and manufacturing flaws cause sleeve rotation and block oil flow, which leads to transmission failure.

Current aftermarket replacement shafts are known to have several problems that can lead to transmission failure. The internal sleeve can rotate, blocking oil flow. The internal passages can cross leak. Metal chips can be hidden inside that cause transmission damage when oil flow carries them throughout the transmission. Sonnax now offers OEM replacement stator support shafts, 77918S-08K & 77918S-09K, with bushings. Each shaft is 100% leak tested to ensure the highest quality.

Replace worn or damaged stator shaft with this universal stator support kit.
