## Burned bands, rear servo piston sticking/breakage

## Servo Pistons

### Sonnax Part Summary

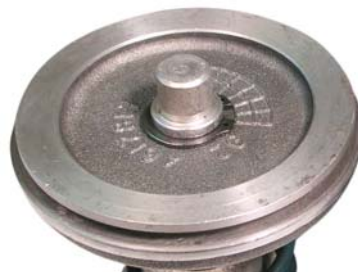
**OEM version of 22912B**  
47RH/RE, '94-'96

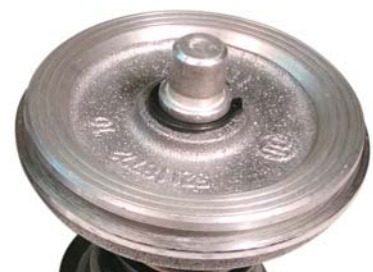
**OEM version of 22912C**  
47-48RE, '97-Up
