Worn pressure regulator valve bore, low pressure, gear ratio codes

Pressure Regulator Valve & Sleeve Kit

55211-08K

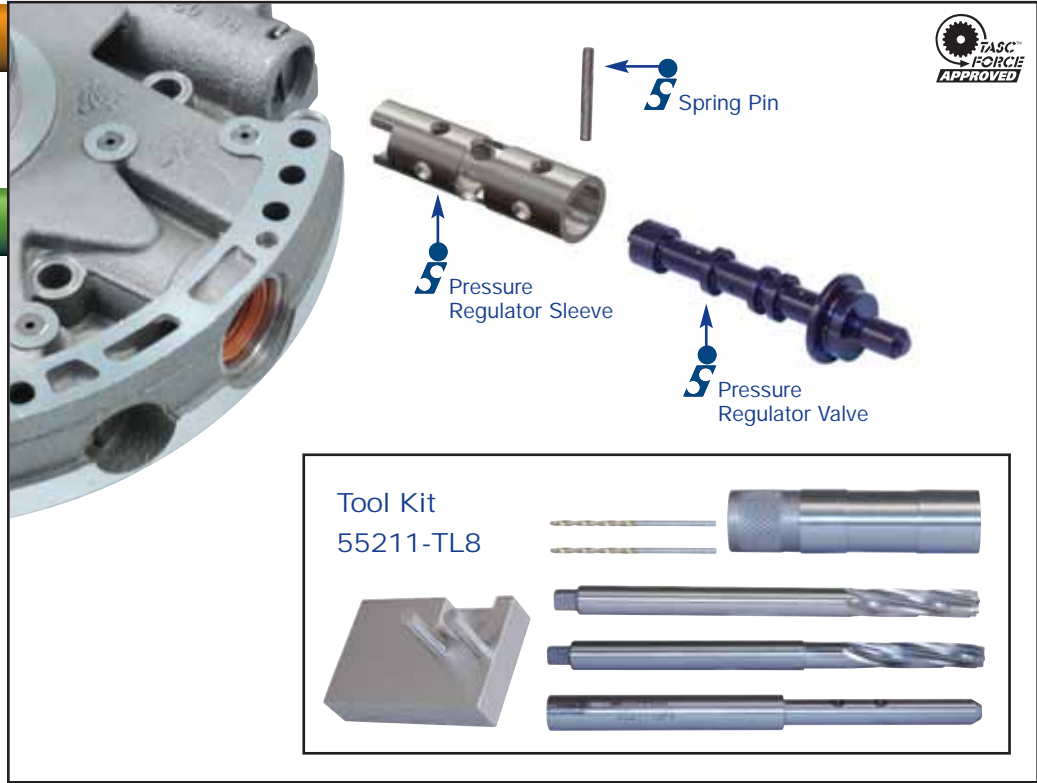
- 1 Pressure Regulator Valve
- 1 Pressure Regulator Sleeve
- 1 Spring Pin

- 2 Drill Bits
- 1 Drill Guide
- 1 Guide Pin
- 1 Reamer Guide
- 2 Reamers

NOTE: This tool kit should not be used on the 4L60-E pump. The aluminum used on the 4L60-E pump is much harder than the 5L40-E, and will reduce reamer life.

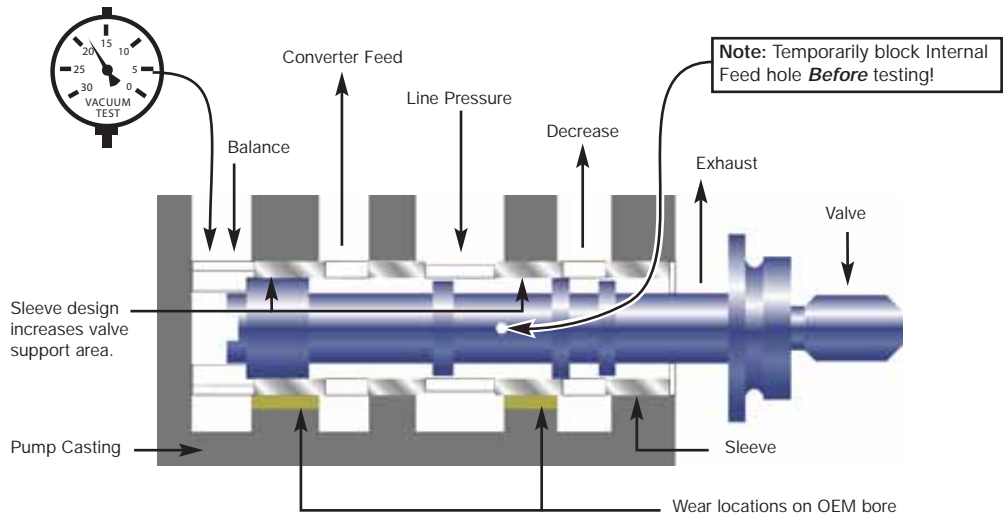
A vacuum test at the Balance port (*indicated below*) holds less than 18" of vacuum. You must temporarily plug the Internal Feed hole to conduct this test. Be sure to un-block Internal Feed when done.
