FORD 5R55N

1 56947J-05K*
Oversized TCC Control Valve Kit

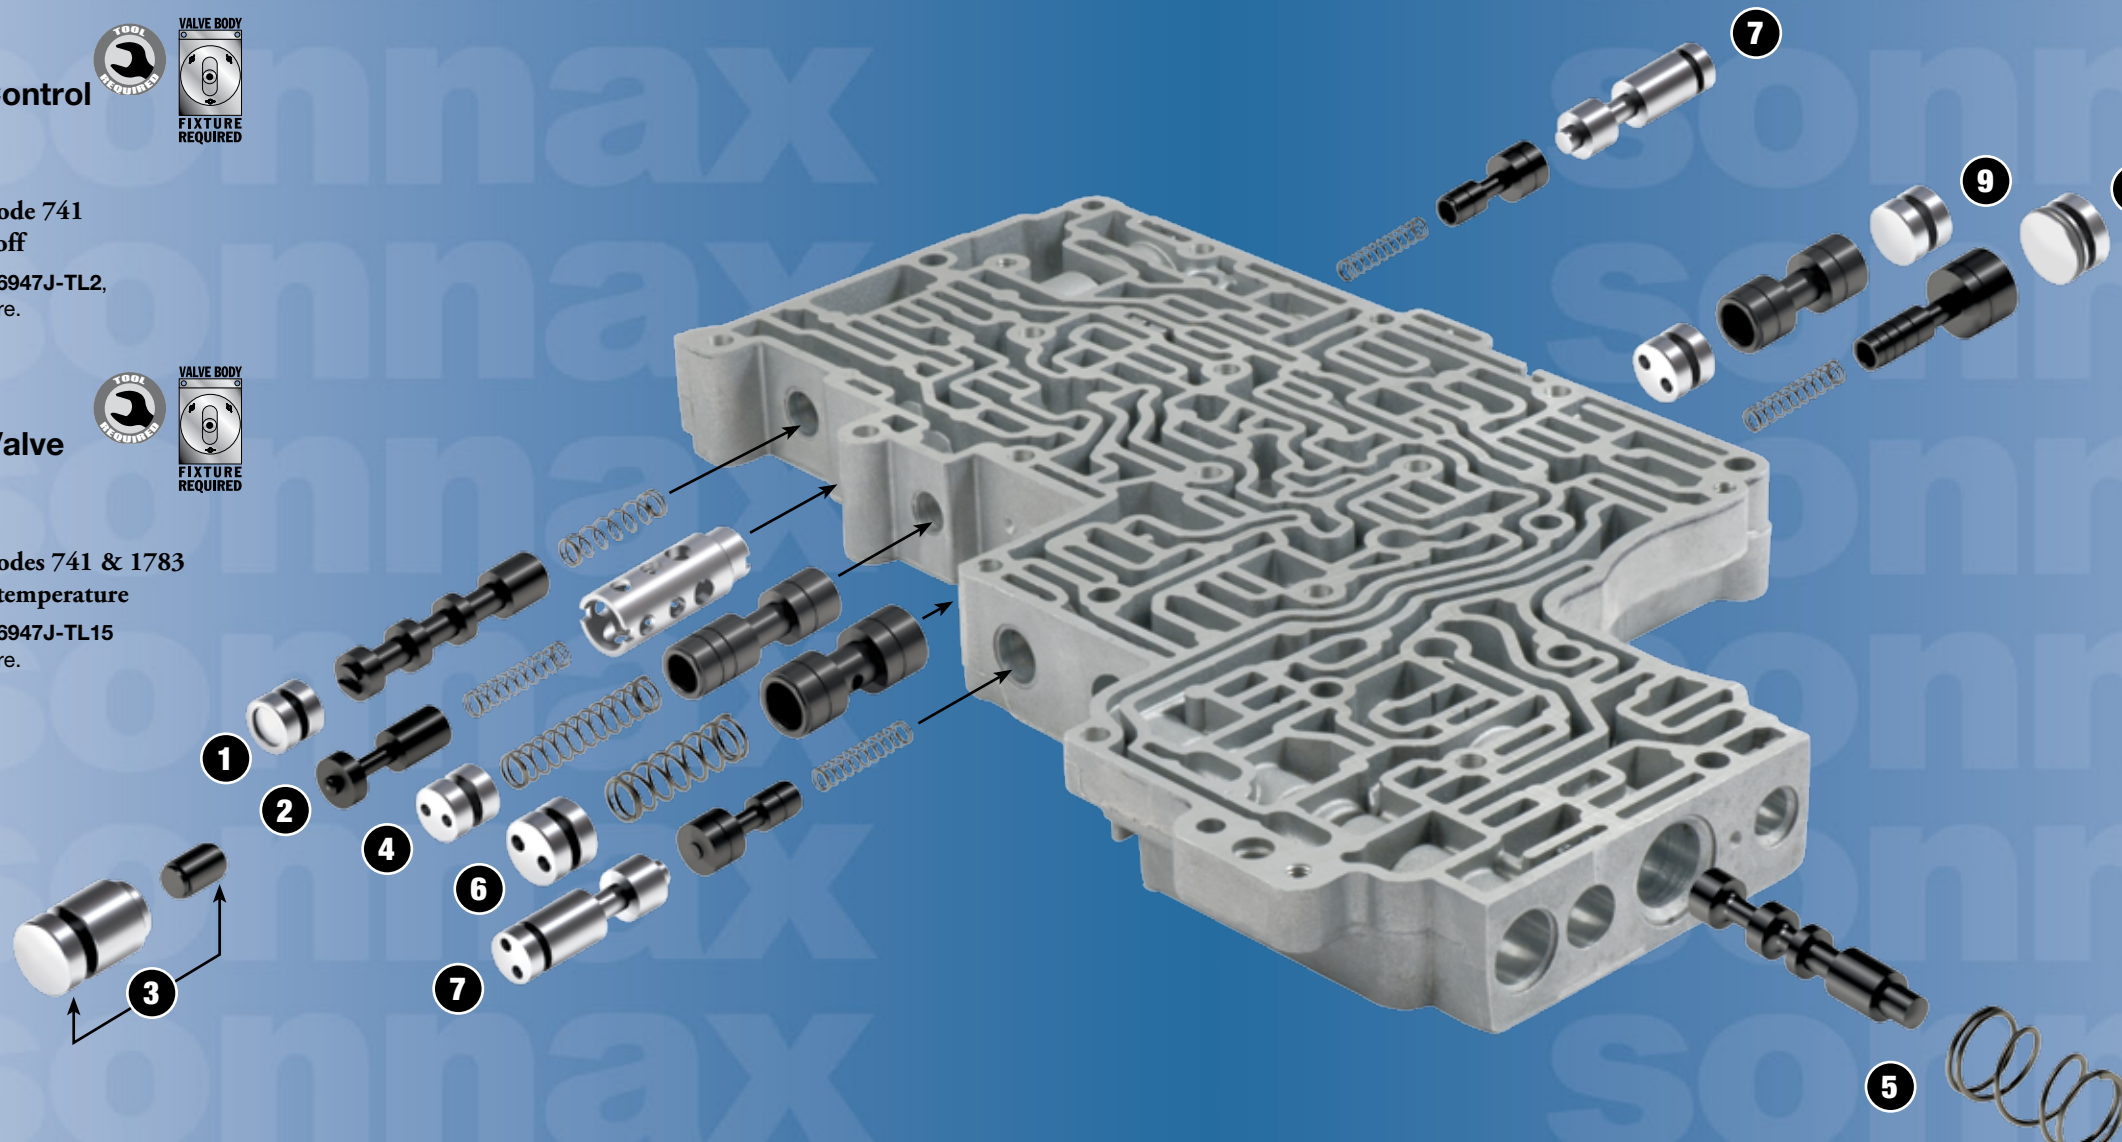
Helps cure:

- Excess TCC slip, Code 741
- TCC lining comes off

2 56947J-15K*
TCC Modulator Valve & Sleeve Kit

- Excess TCC slip, Codes 741 & 1783
- Transmission over temperature

3 56947J-32K
TCC Modulator Sleeve & Plunger Valve Kit

4 56947J-63K
Converter Clutch Back Pressure Valve Kit

5 56947J-39K
Pressure Regulator Valve Kit

6 56947J-56K
Forward Engagement Valve Kit

7 56947J-49K
PCA/PCB Modulator Valve Kit Fits either of 2 locations.

8 56947J-53K
Reverse Modulator Valve Kit

9 56947J-59K
Reverse Engagement Valve Kit
